RUN-OFF RAINWATER HARVESTING PROJECT, ZAMBIA

**Lloyd Samson Thole – Assistant Registrar,
Workshop on Access to Scientific and Technical Information for
Technological Capacity Building and Product Branding for Goods of
Export Interest for English Speaking LDCs
21 to 24 October 2014, Harare, Zimbabwe.**

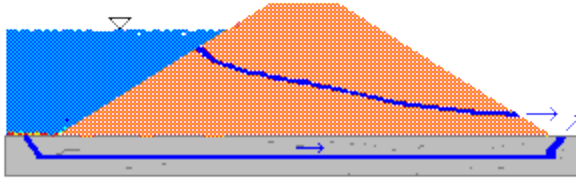
Piping is started by soil erosion which normally occurs at the downstream toe and forms channels or pipes through the embankment. The bottom of the impoundment as well as the curtain receives a lot of water pressure due to sloping of the floor creating a deep end effect.

- Piping is loss of water caused by soil erosion through the embankment which is a very common feature for such water impoundments that use earth barriers

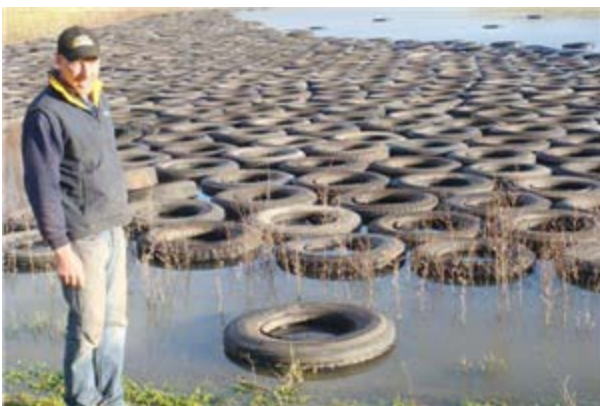
Used Tyres

- Evaporation
 - Evaporation of water from impoundments can be reduced using chemical monolayers for large impoundments but for small impoundments, floating or suspended evaporation barriers can be used and these range from grass thatch covers and floating cloth membranes, timber, used tyres are placed on the surface of the water to reduce contact of wind with water.

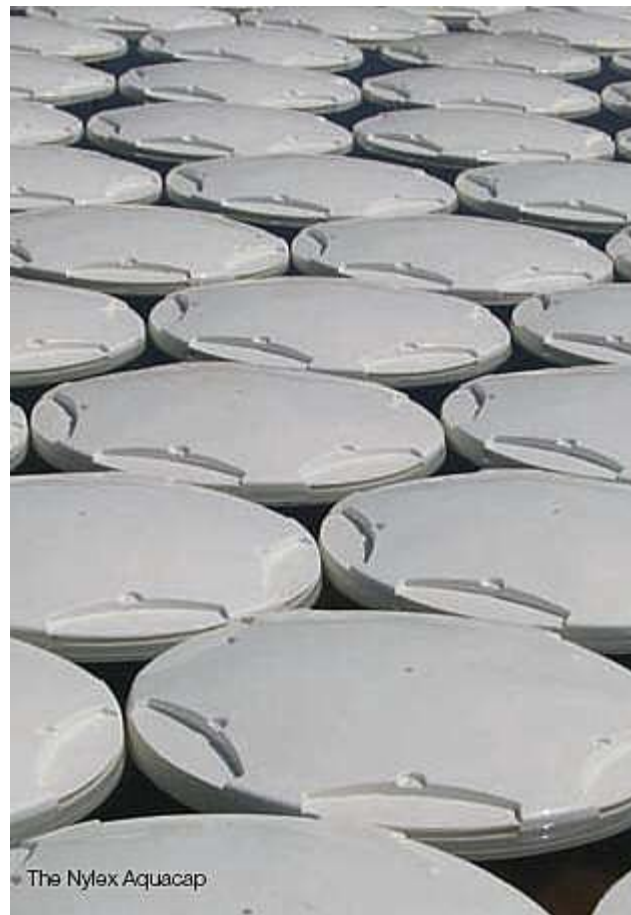
Aqua cap

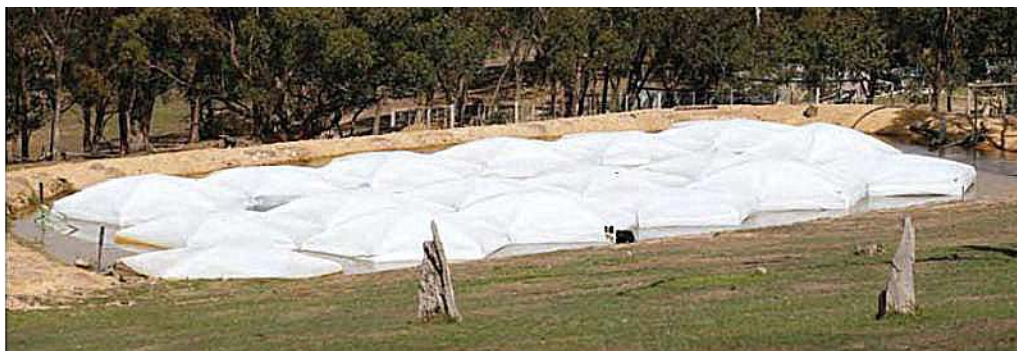
Raftex cover

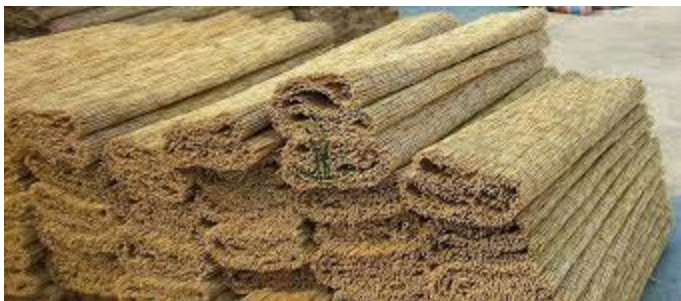
Reed Mats

- The use of local reed mats as an evaporation barrier has never been used anywhere in the world and therefore, this has been recommended as part of the PACRA innovation.
- The problem of piping once proven will be addressed next year because it involves land grading using a bull dozer which should be budgeted for later.

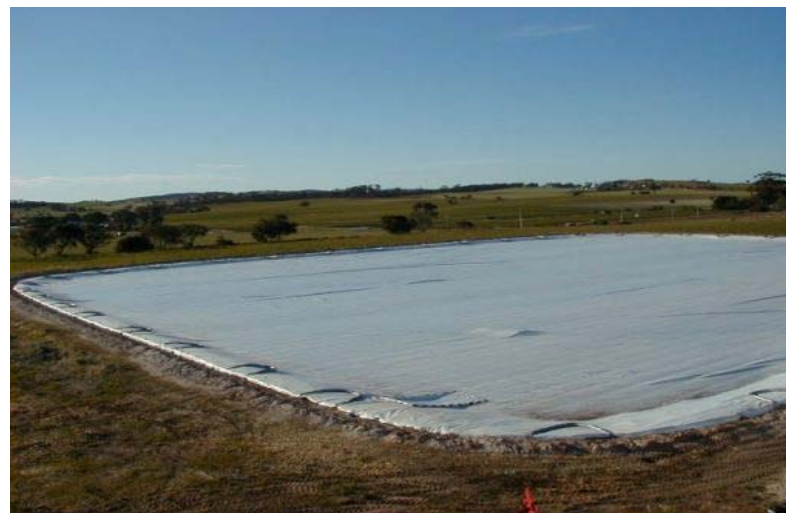
Evap Cap

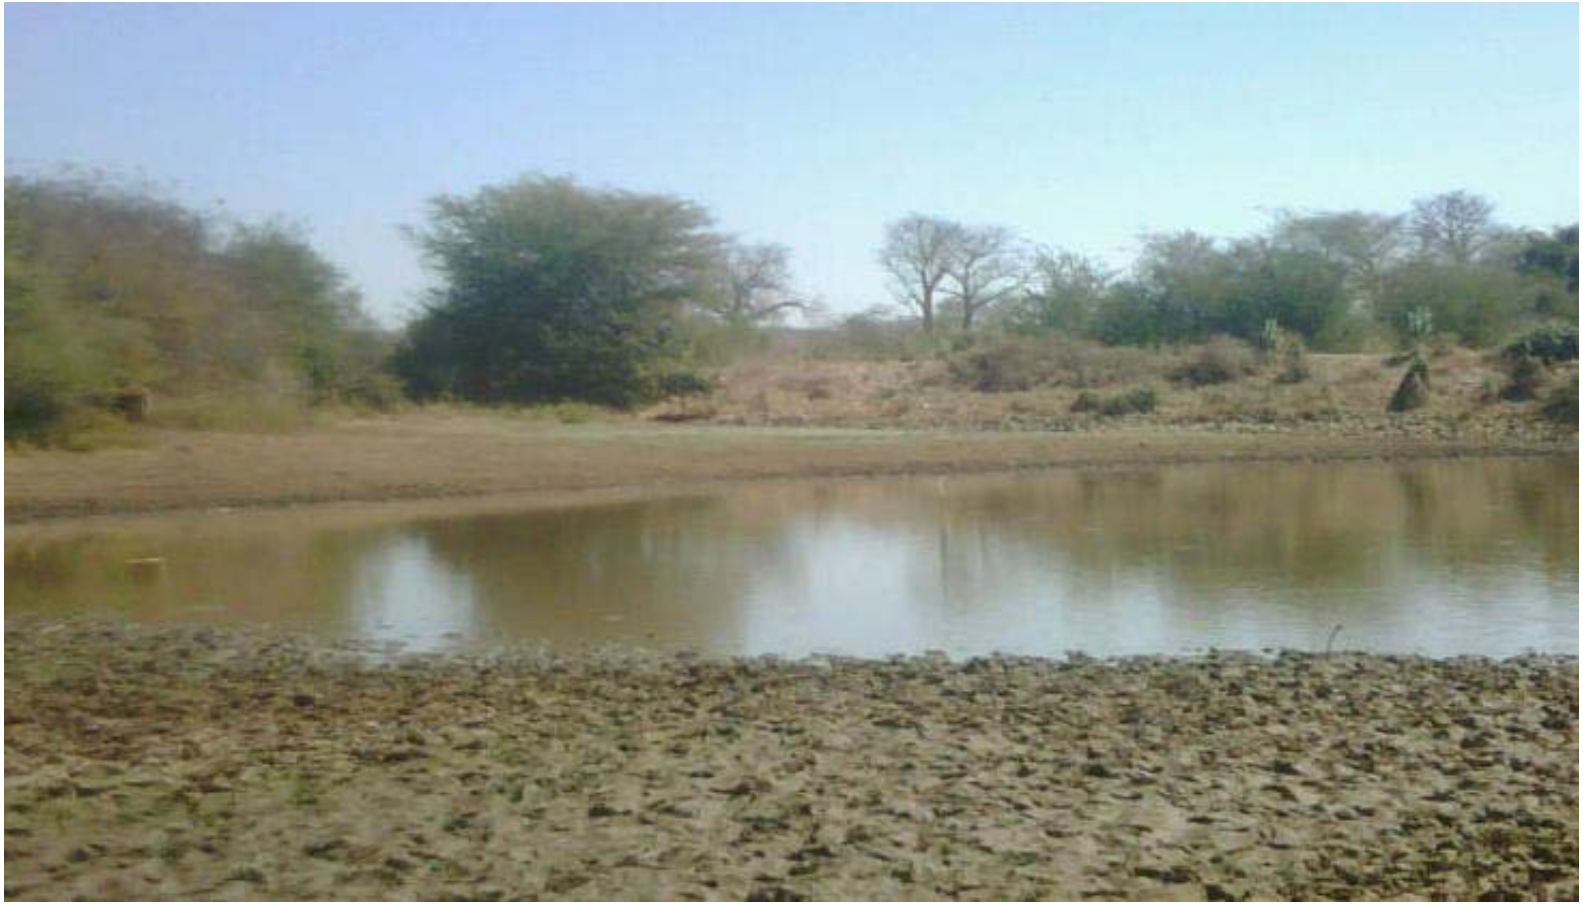
One of the channels leading to the impoundment

- The land in the area recommended for application of our technology slopes at approximately 5° to the south west and it is characterised by several ephemeral channels that become loaded with water during the rainy season and flows towards the impoundment.
- The topography within the Zambezi rift valley is undulating to flat with isolated elongated north east south west trending ridges composed of more resistant out crops of the basement rocks.
